Title: Product wind, water and impact resistance testing of a sample of Aerobrick rainscreen cladding for TI Tiles International Ltd

Report No: N950-18-17536

Title: Product wind, water and impact testing of a sample of Aerobrick rainscreen cladding for TI Tiles International

Customer: TI Tiles International Ltd
Westview House, Devro Campus
Gartferry Road, Moodiesburn G69 0JE

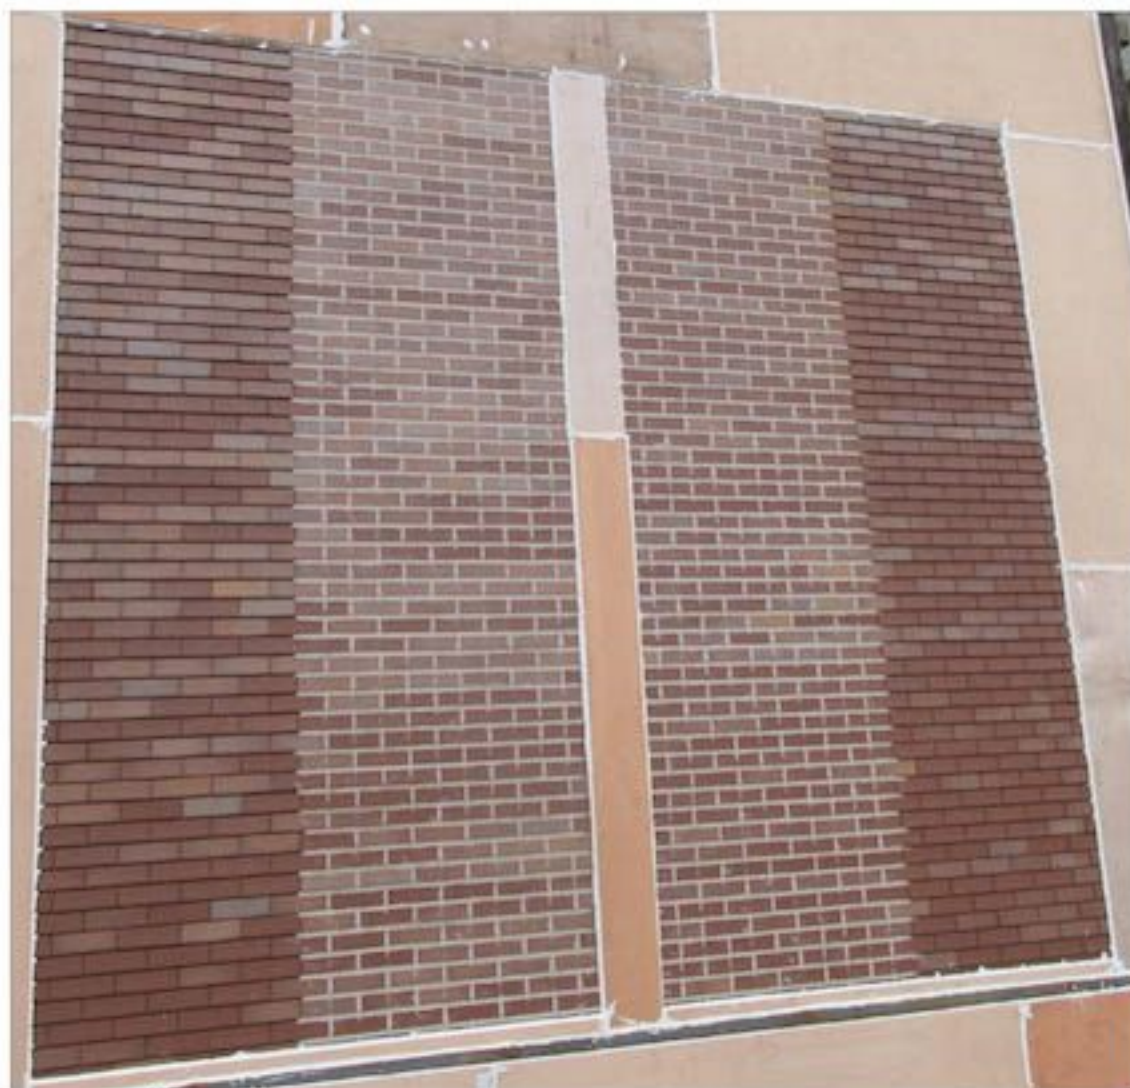
PHOTO 6845

The sample was as shown in the photo below and the drawings included as an appendix to this report.

TEST SAMPLE

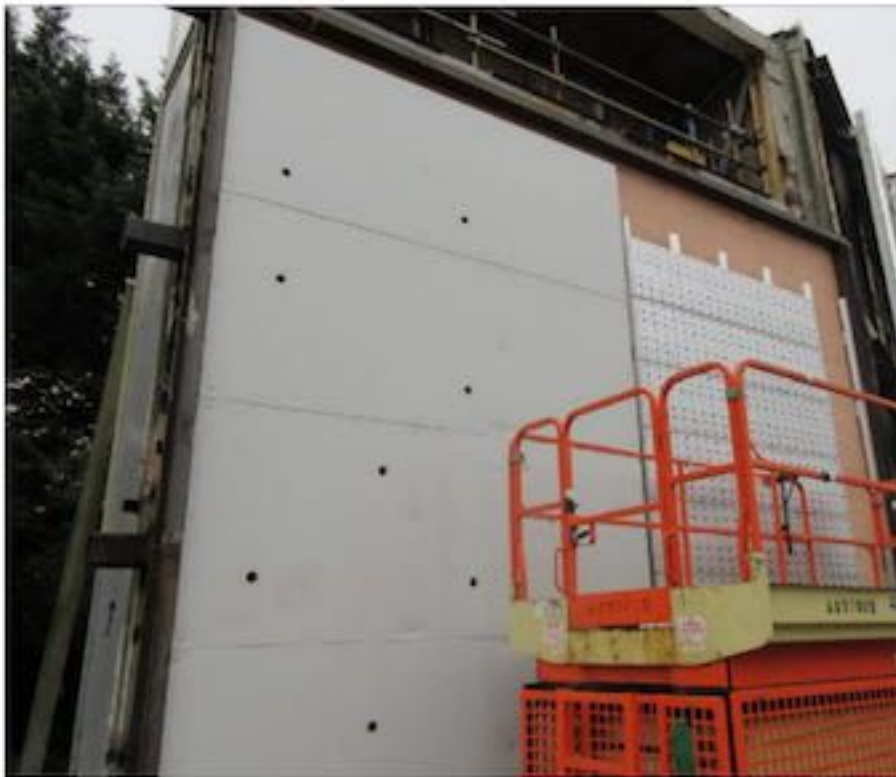
PHOTO 6429

SAMPLE DURING BUILD

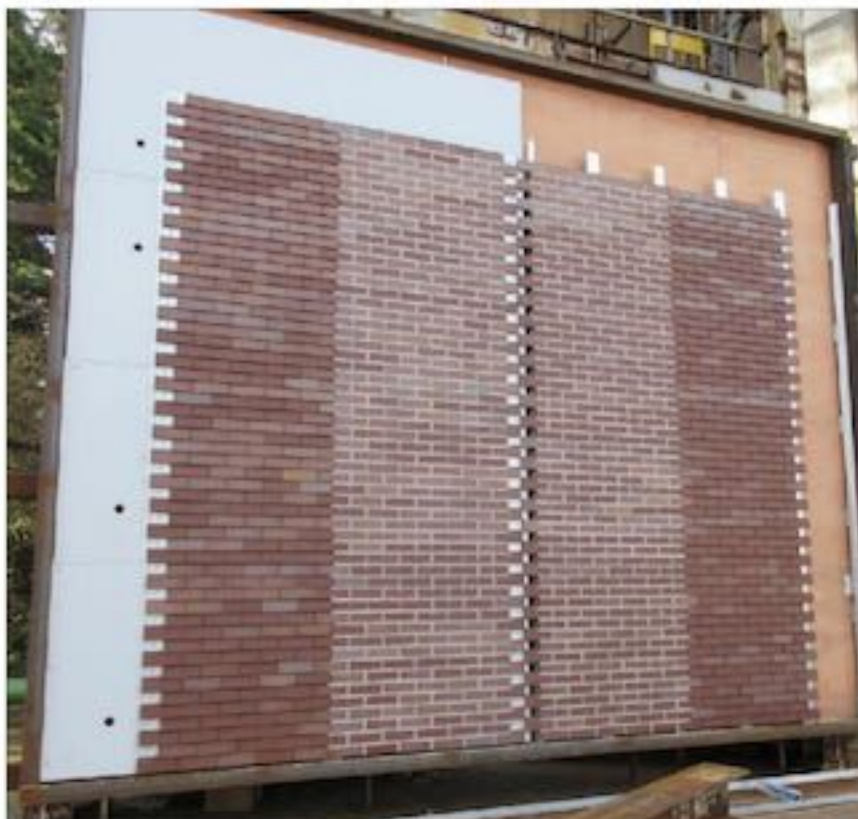
PHOTO 6794

TEST SAMPLE DURING BUILD

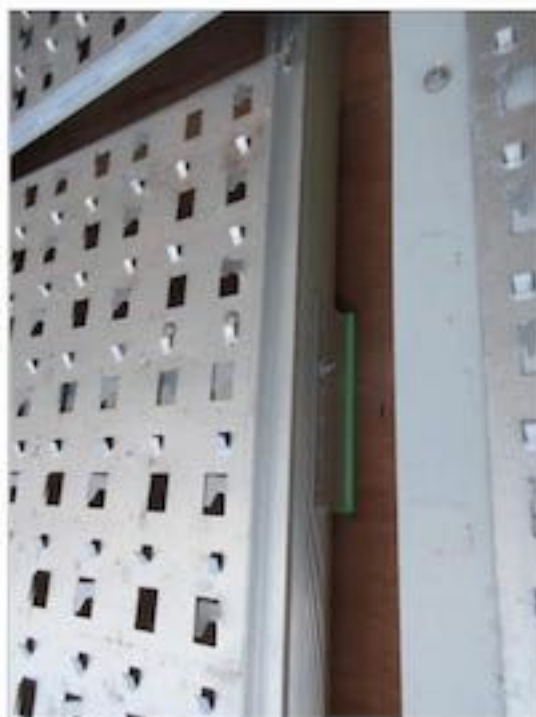
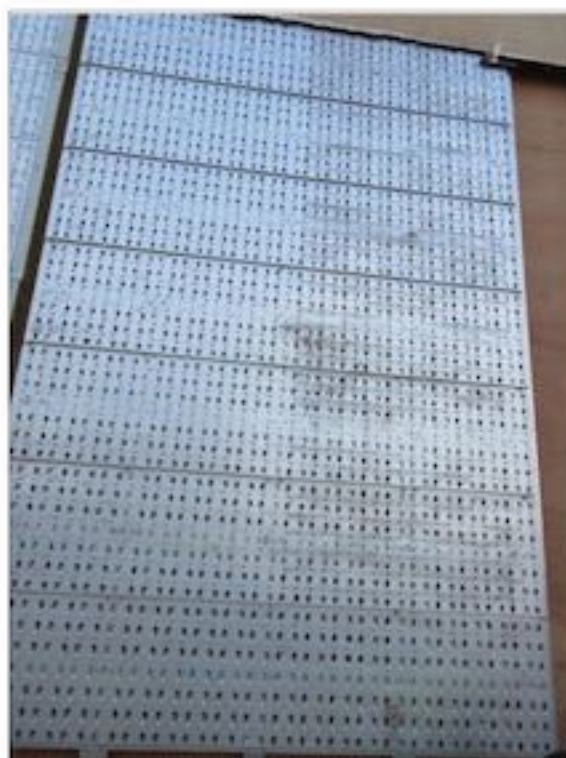
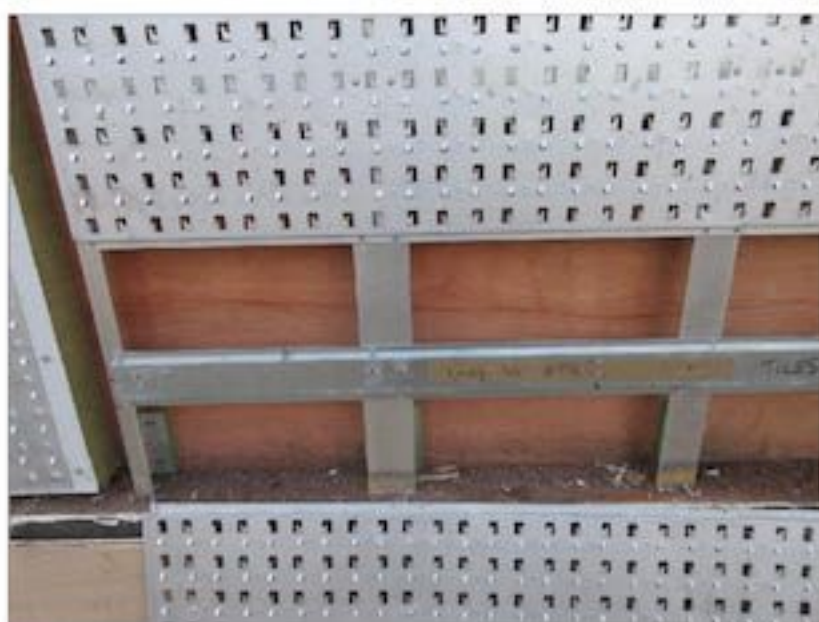
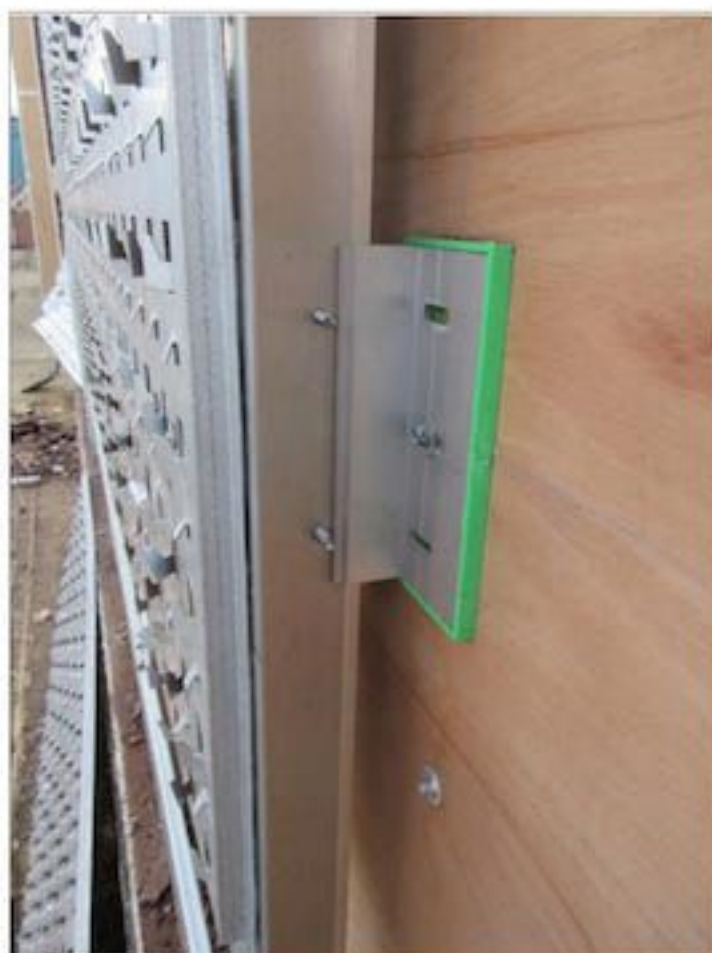
During the dismantling of the sample no discrepancies from the drawings were found.

TEST SAMPLE DURING DISMANTLE

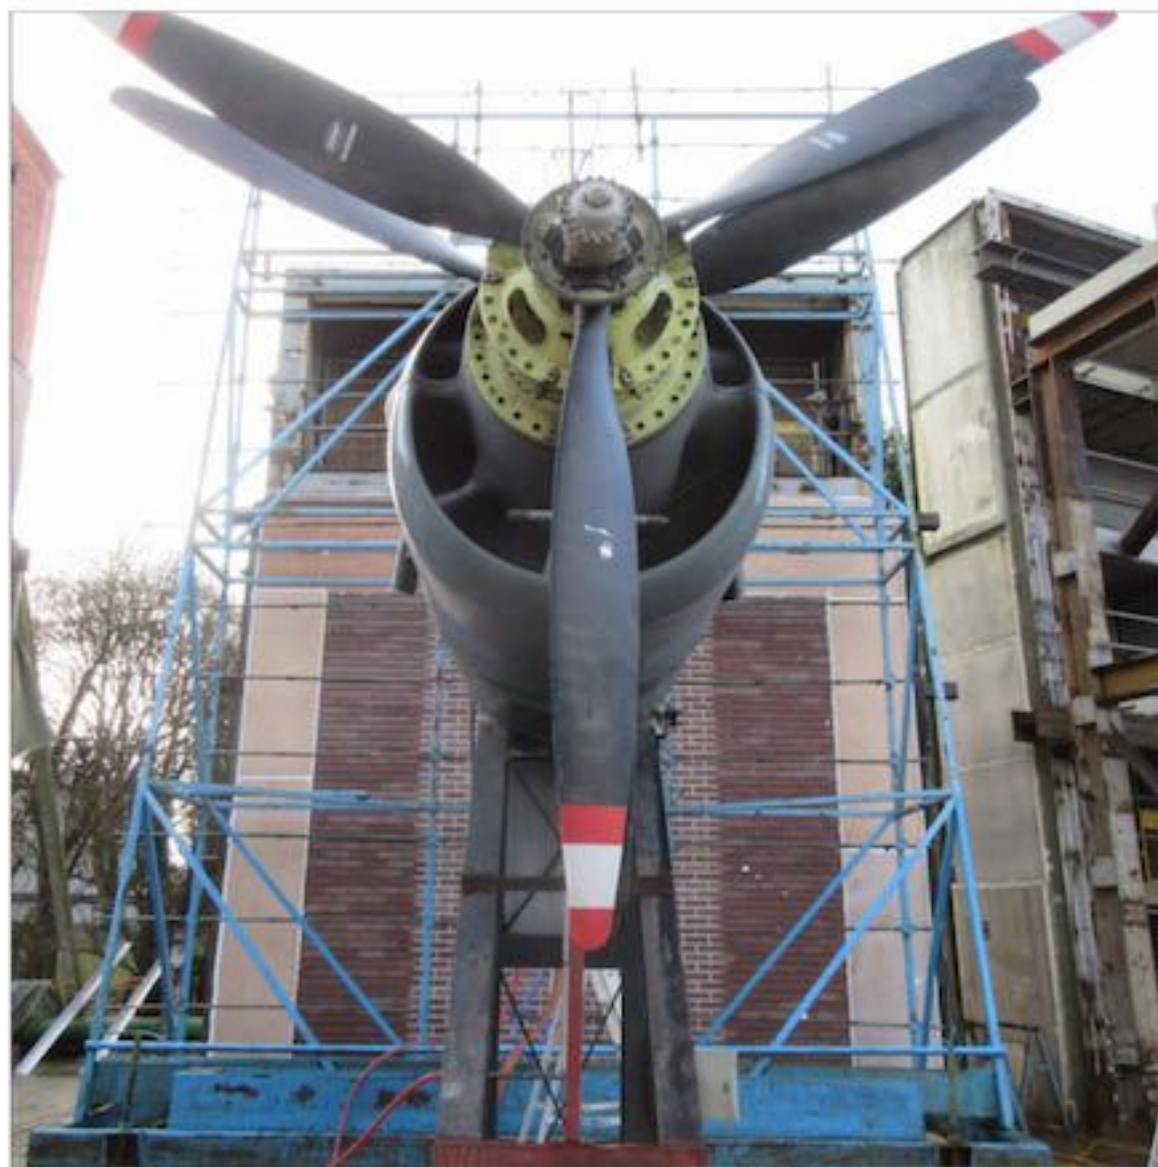
PHOTO 6901

A wind generator was mounted adjacent to the external face of the sample and used to create positive pressure differentials during dynamic testing. The wind generator comprised a piston type aero-engine fitted with 4 m diameter contra-rotating propellers.

DYNAMIC WIND GENERATOR

The aero-engine was used to subject the sample to wind of sufficient velocity to produce average deflections in the principle framing members equal to those produced by a static pressure differential of 600 pascals. These conditions were maintained for 15 minutes. Throughout the test the inside of the sample was examined for water penetration.
